## Station Description Sheet **PRO**

**Station Code:** PRO

**Network:** Euroseis

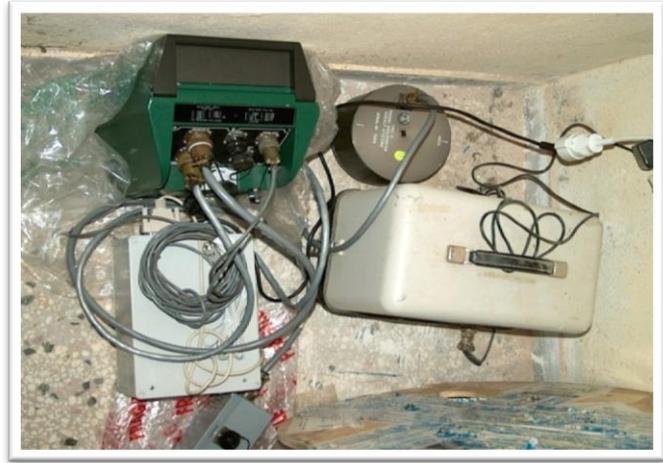
**Photo 2:** Inside of the PRO station

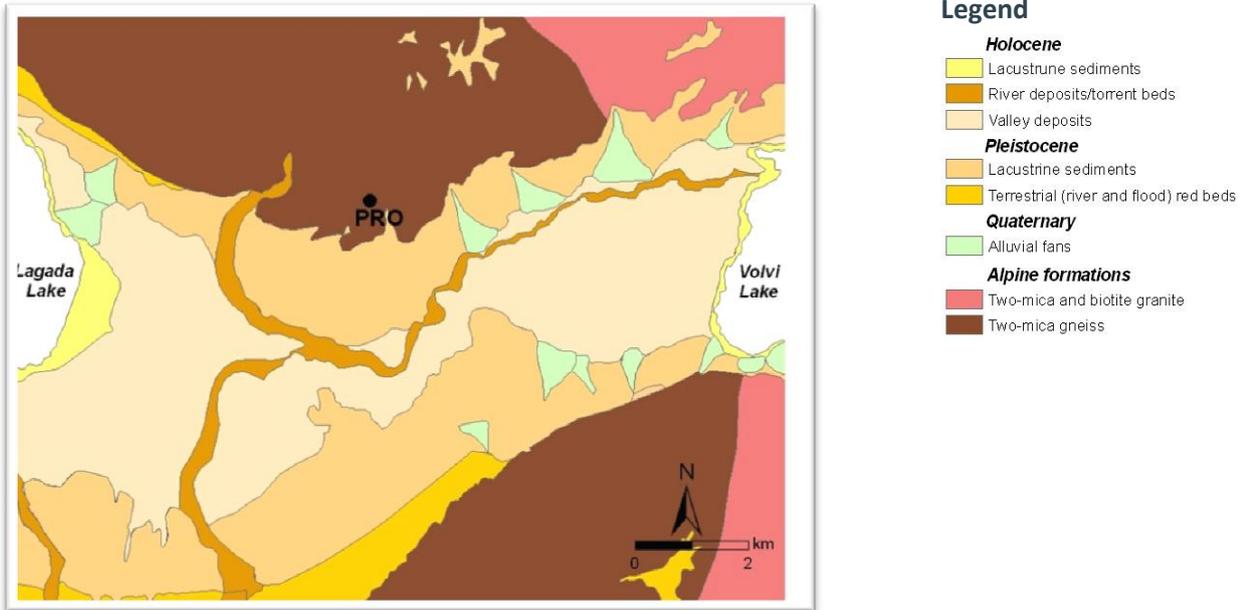
Figure 2: Geological map of the central Mygdonian basin

**Surface geology (from geological map):** on two-mica gneiss

**Reference for geological map:** Geological map of Greece - Scale 1:50000, Map Sheets of "Thermi" and "Zagliverion", (IGME, 1978)

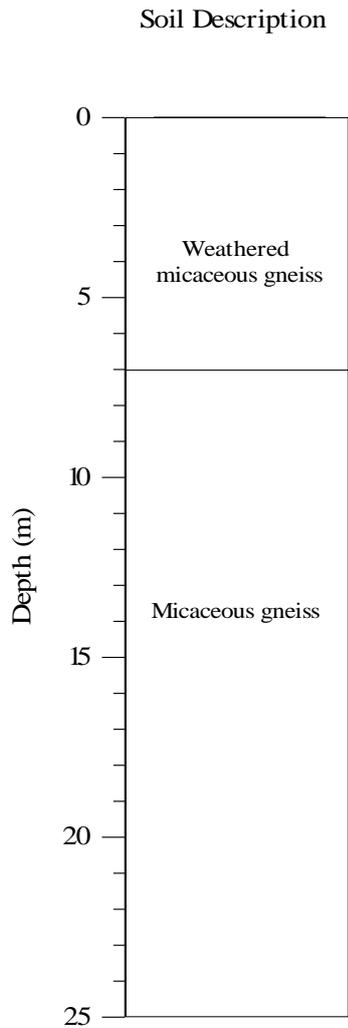
**Figure 3:** Geotechnical data at station PRO

1. Sampling borehole (EUROSEISTEST Project Reports, 1993-1995)
2. Laboratory tests (G- $\gamma$ -D curves, etc.) (EUROSEISTEST Project Reports, 1993-1995)

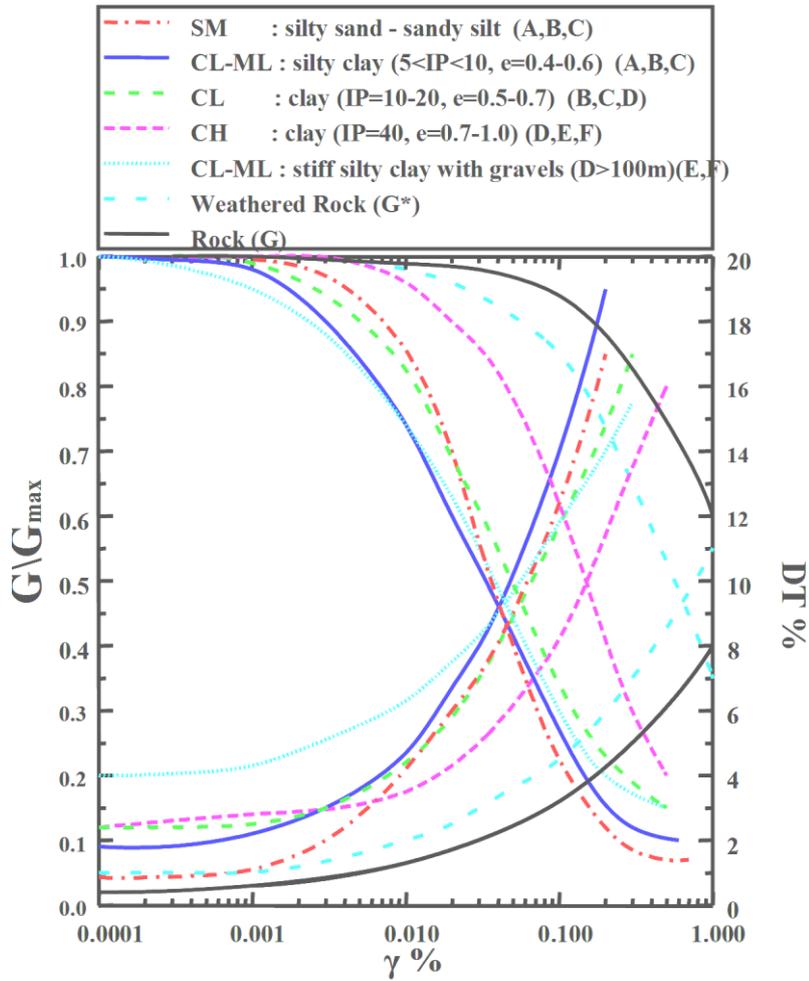
**Figure 4:** Mean  $G/G_0$ - $\gamma$ - $D$  curves from resonant column and cyclic triaxial tests for all geotechnical formations occur at station PRO. The curves describe the shear modulus degradation with the shear strain and the respective internal damping increase.

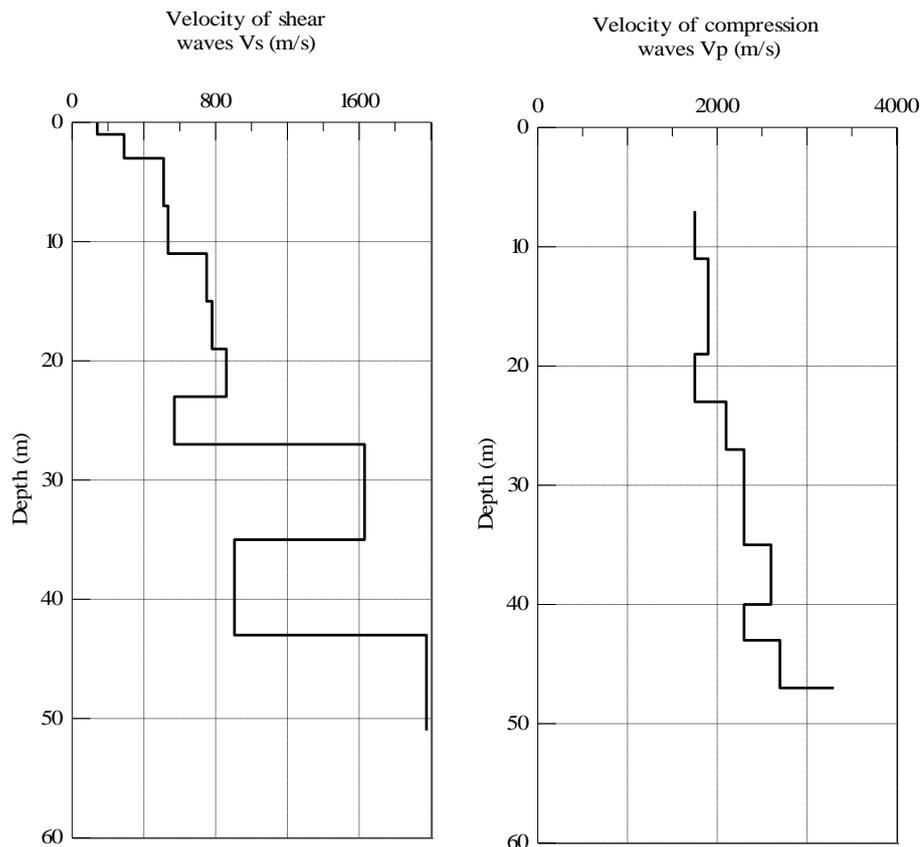
**Figure 4:** Shear and compression wave velocity values at station PRO

1. Shear wave velocity values ( $V_s$ ) / determined by Surface Wave Inversion method (Raptakis et al., 2000)
2. Compression wave velocity values ( $V_p$ ) / determined by P-wave logging (Raptakis et al., 2000)
